**WEST WITS  
MINING**

# **Mud Rush Incident at Qala Shallows Mine: A Technical Overview**

**Date: 03 September 2026**

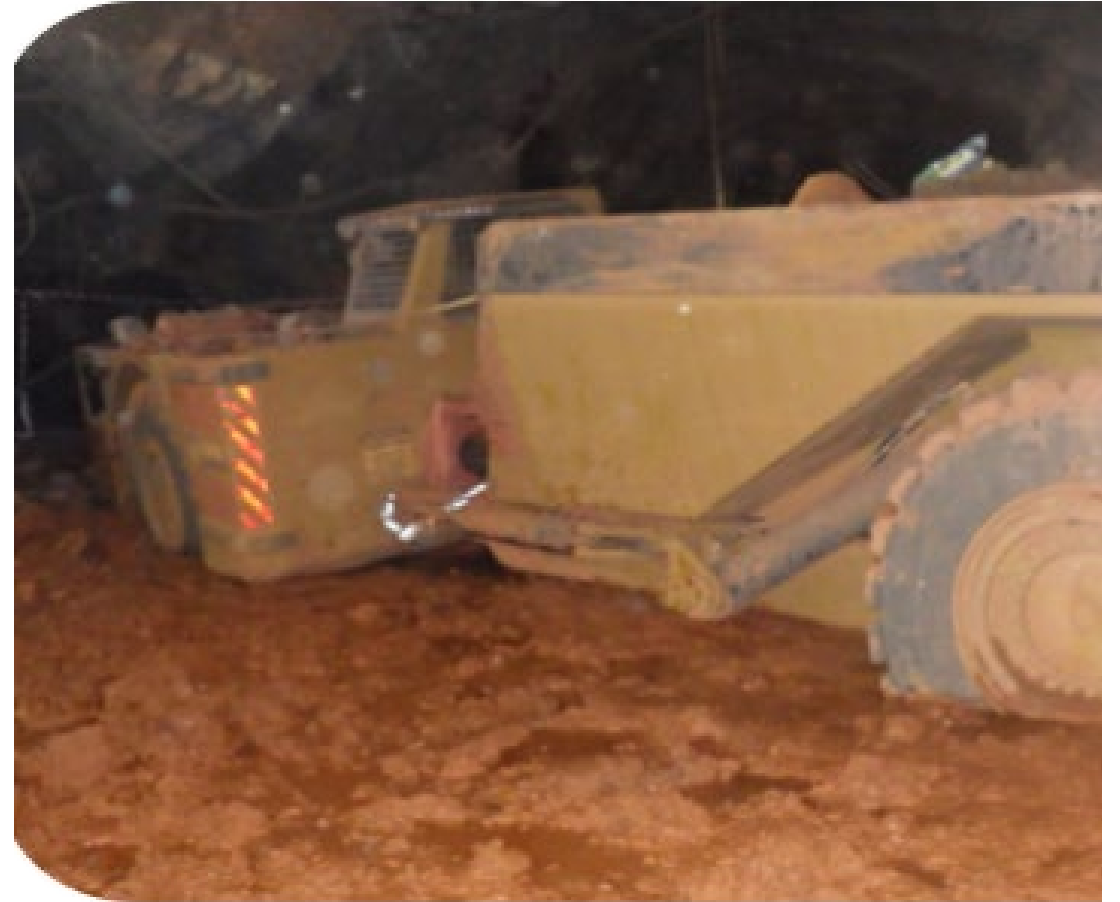
➤ On the 7<sup>th</sup> of June 2026, while the team was loading from muck bay 1 the dump truck was being loaded by the LHD and was parked at intersection of 1east and 1West decline. A mud rush incident occurred from 1 East decline cubby around 23:47. The driver exited the truck attempting to evacuate away from the mud rush, and regrettably he was overpowered by the mud rush.

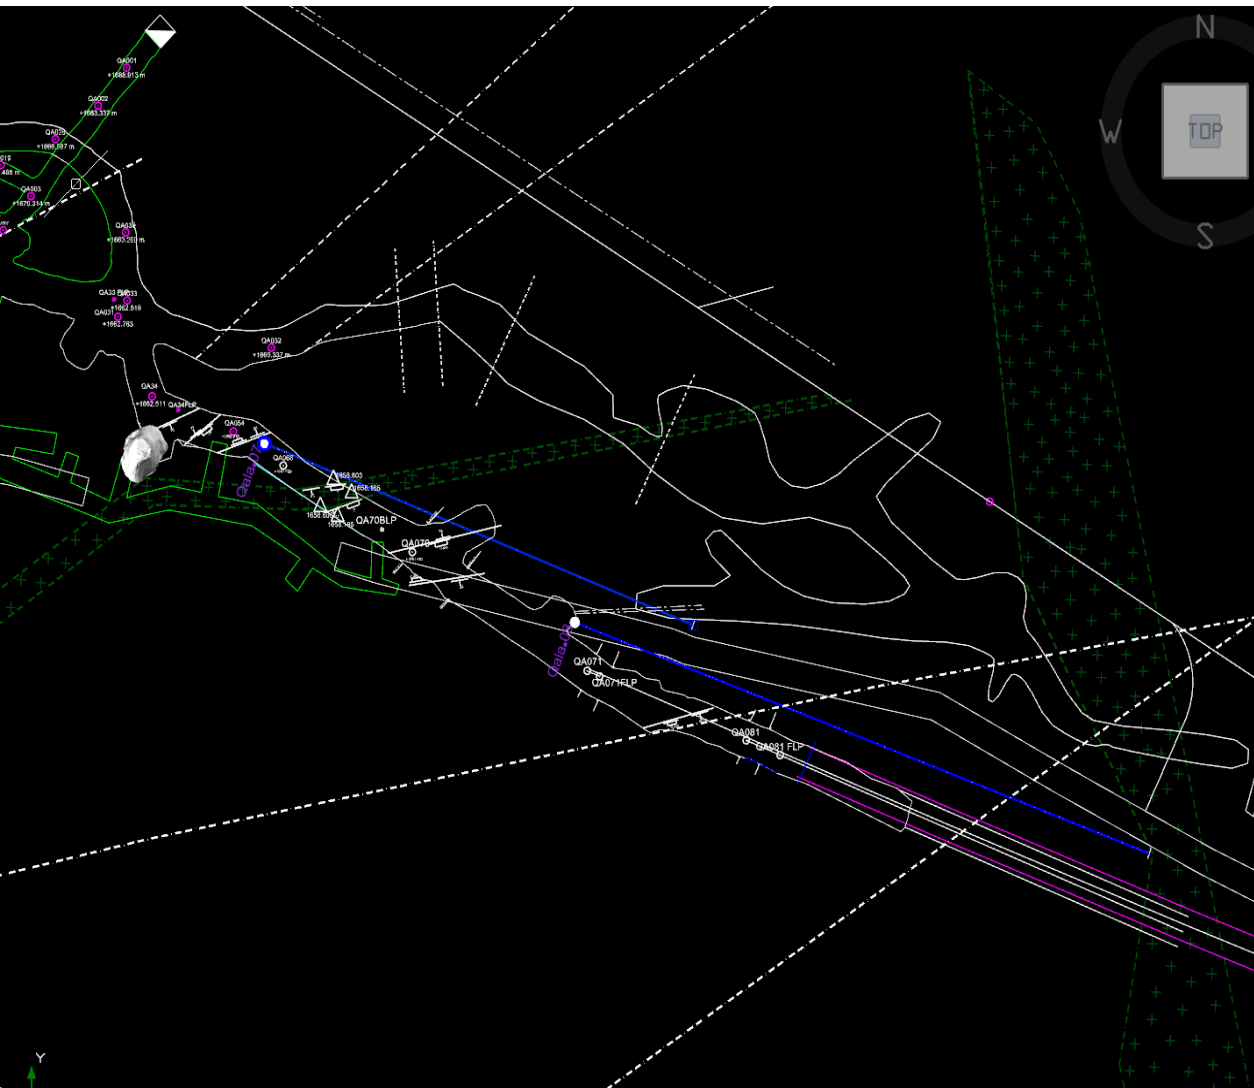
## QALA-007 – 04 OCTOBER 2025 TO 11 OCTOBER 2025

- This drillhole was drilled from the decline face.
- Collar position was approximately 13m east of 1 East Decline Muck Bay.
- A total of 71.73m was drilled.
- The hole was drilled at  $-9^\circ$ , in line with the planned decline inclination.
- A dolerite dyke was intersected between 10.72m- 18.64m
- **The dolerite dyke intersected is dark grey to black in colour, with altered and backed contacts.**
- The core shows faulting before and after the dyke.
- **No water or noxious gas was intersected on this drillhole.**

## QALA-008 – 18 FEB 2026 TO 17 MARCH 2026

- This drillhole was drilled from a cubby.
- The planned depth was 120m, however, drilling was stopped at 96m.
- Drilling was stopped prematurely due to water intersection ahead of the decline face.
- **The water intersection position was  $\pm 36$ m ahead of the decline face.**
- **The measured flow rate was 2litres/ 5 second, equivalent to approximately 1440 litres/ hour.**
- **The initial plan was to drain the water and seal off the hole, but this was not completed due to a mud rush (19 March 2026) at 1 East Decline.**
- The drillhole was also drilled at  $-9^\circ$  consistent with the planned decline development.
- **No noxious gas was intersected.**

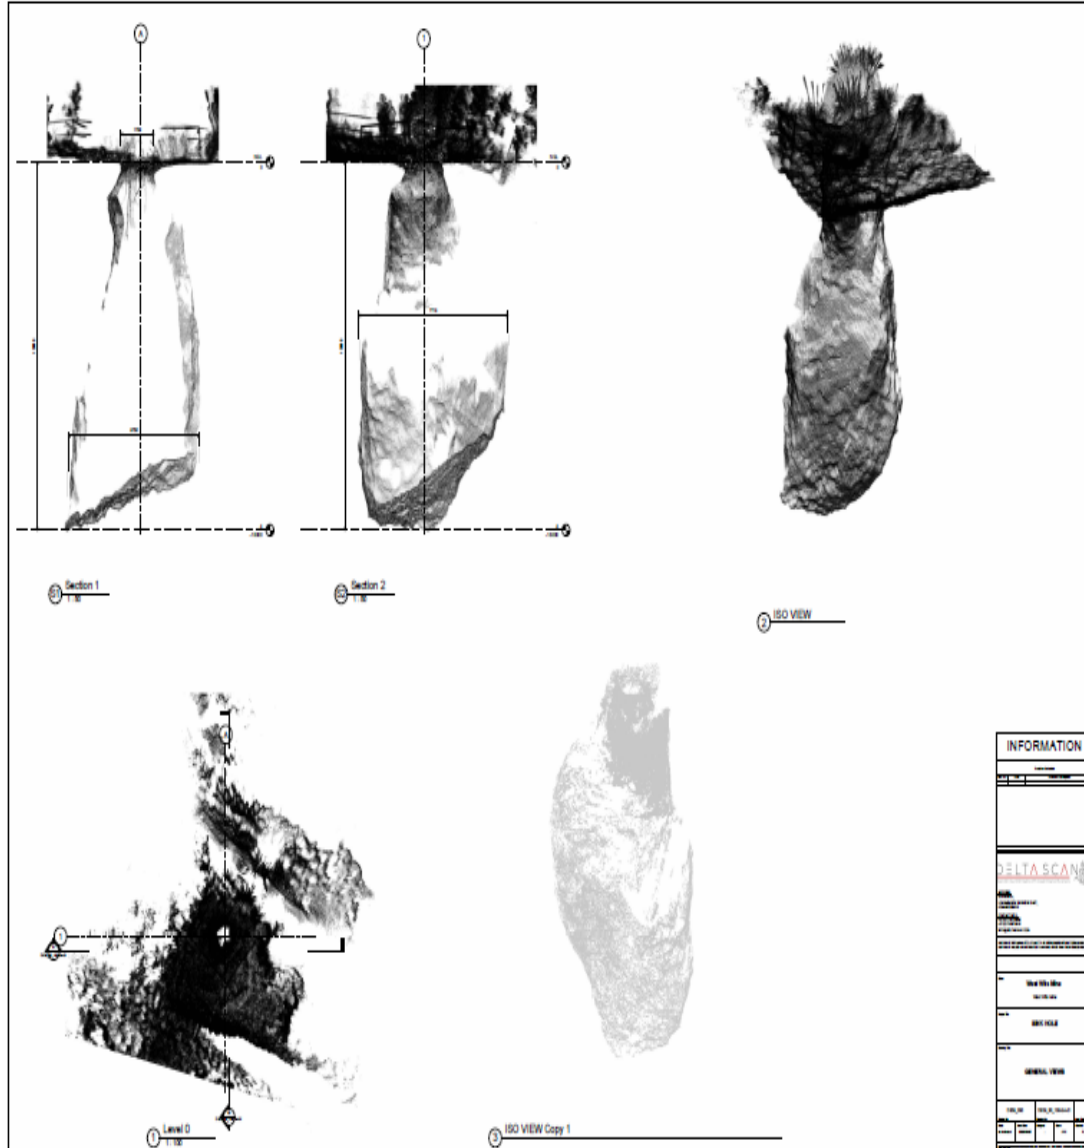
A Drone Survey on the subsided area was conducted on the **22<sup>nd</sup> of March 2026**, and subsidence depth was identified as **12.9 metres volume of 255,9 cubic meters**. The following remediation activities were undertaken:

- Surface area fenced off with a security fence on the 23<sup>rd</sup> of March 2026.
- Tailings water was redirected away from the cavity on surface by means of trenches on the 24<sup>th</sup> of March 2026 Report NO; MDI2026-0059.
- Water pumped out from the surface cavity on the 17<sup>th</sup> of April 2026, Report No; TDC 22 2026 04.
- Surface cavity was filled with a cement plug, Report No; TDC 22 2026 04. –
- Recommendation was made that no activities at 1 east decline until cement is cured and multi-disciplinary risk assessment has been conducted on the 7<sup>th</sup> of April 2026, Report No; TDC 22 2026 04.
