# MPONENG OPERATIONS

**JOURNEY TO A  
SAFER WORKFACE**

PERMANENT WORKFACE  
NETTING & IMPROVED  
VISIBILITY

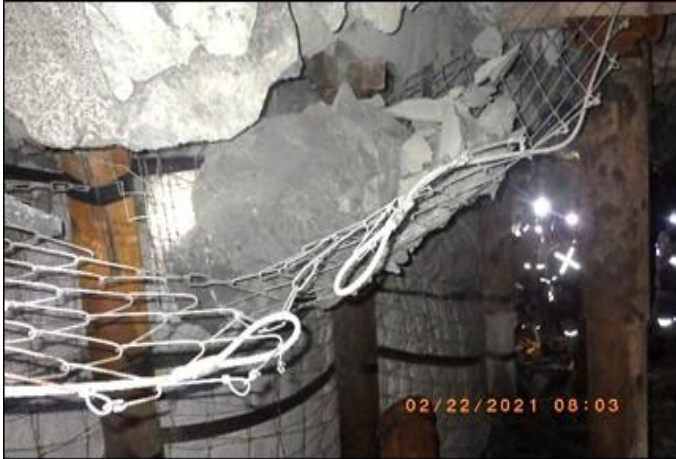
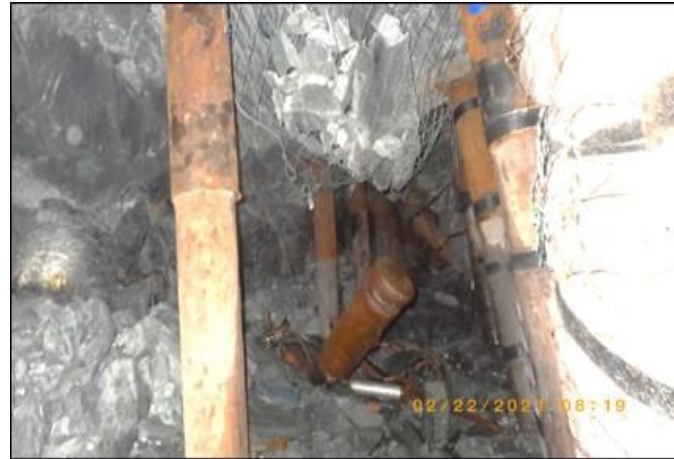
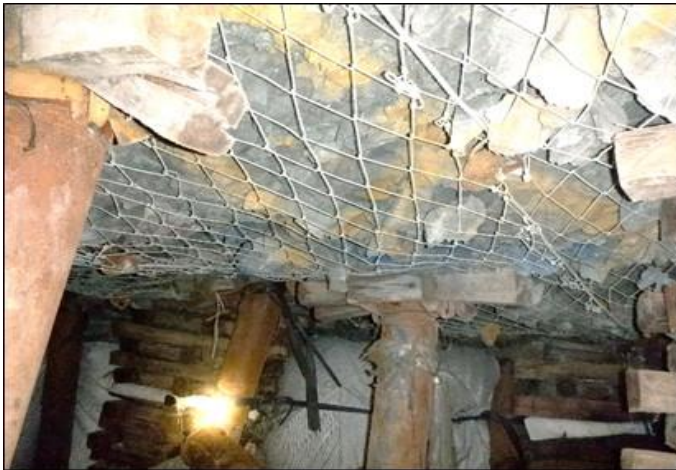
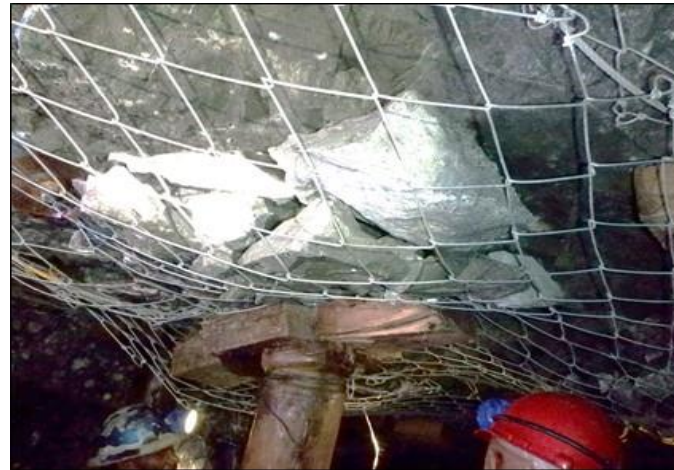
# PERMANENT WORKFACE MESH IMPLEMENTATION (2021)

- Geobrugg mesh (based on seismic risk)
- Began January 2021
- Completed March 2021

- Overhauled entire support system
- Integrated in-stope bolting to work with mesh

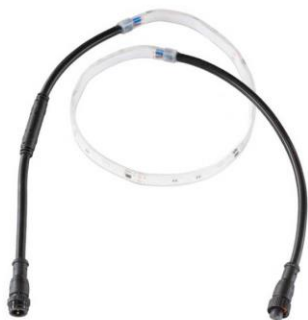
LED Light Strip  
(daisy-chain plug  
and play)  
Note: Removed  
prior to blast

- Rated IP68 ingress protection
- 36 Volt (very low electrocution potential)
- Heavy duty (armoured) extension cord
- 50 Lux at 1.0 m vs. 5-10 Lux for a cap lamp

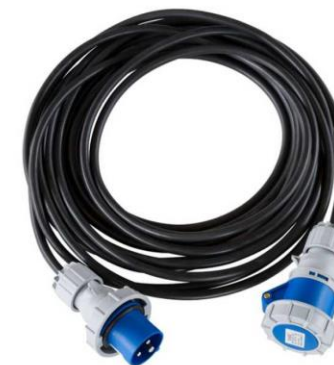
Extension  
Power Cord  
(armoured)
